## PHOTOGRAPH LOG

<b>Project Name:</b> Gold King Mine	<b>Site Location:</b> Silverton, San Juan County, Colorado	<b>Project No.</b> 0001/1408-01
--	---	------------------------------------

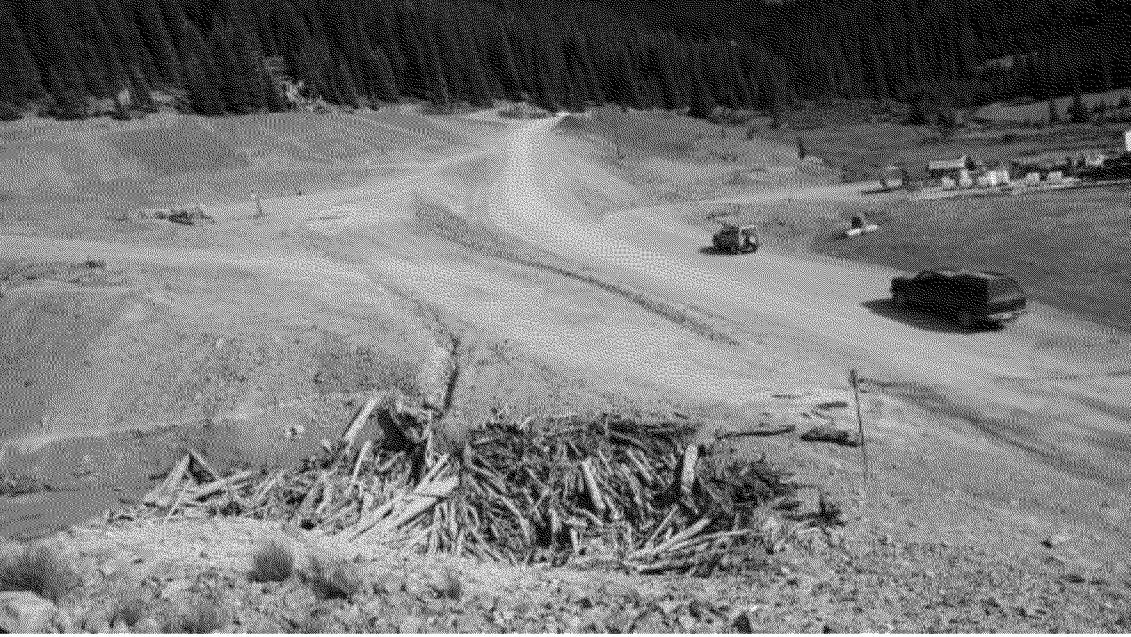
<b>Photo No.</b> <b>54</b>	<b>Date:</b> 08/05/2015	<b>Direction Photo Taken:</b> East
<b>Description:</b>  Cement Creek crossing at Gladstone.
